RACEPAC Flight #11 – Polar 6 – 140516

Report by Stephan Borrmann

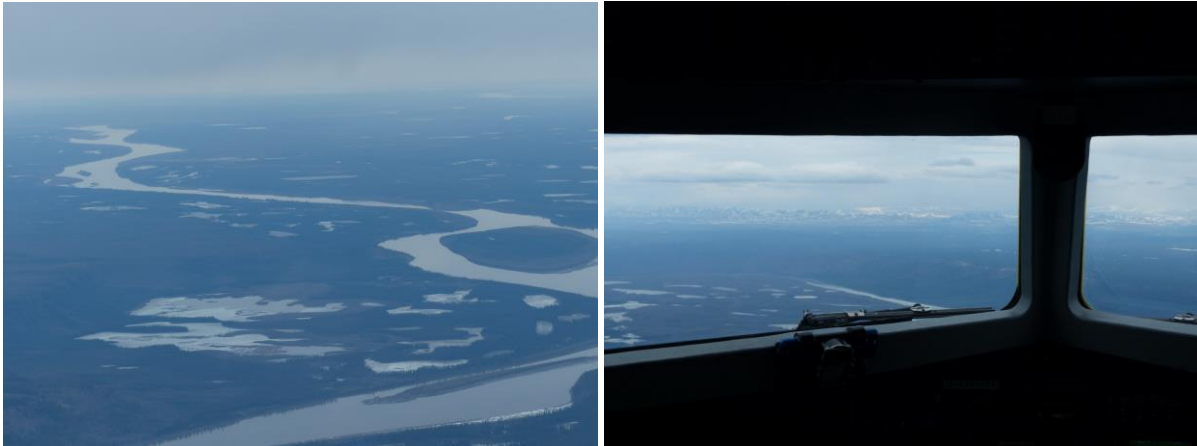
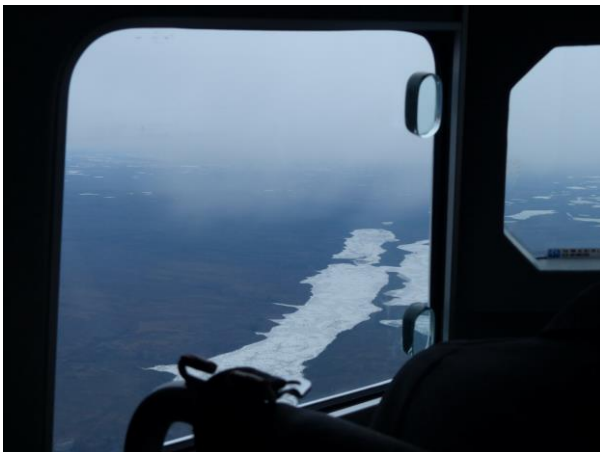
Upper left from 13:10 LT, upper right from 13:02 LT, lower photo from 13:19 LT.

The pictures illustrate the general cloud situation: Upper left diffuse hazy stratus, upper right stratus overhead with cumuliform clouds interspersed, lower photo fall-streak.
